TECHNICAL NOTE

Bureau of Land Management U.S. DEPARTMENT OF THE INTERIOR

EVALUATION OF EXCAVATED FISH REARING POOL IN VINCENT CREEK

John W. Anderson, Fishery Biologist
Coos Bay District, Oregon

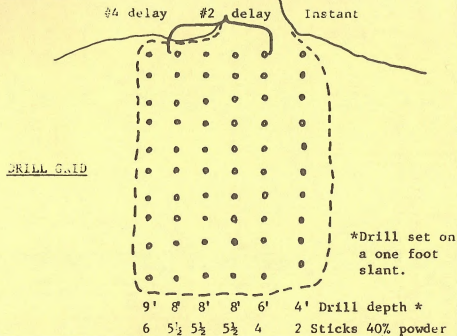
Illustration 1.

An experimental pool was excavated by blasting in the fall of 1970. A track-drill was used to make the powder holes and the material was shot free of the hole by using heavy charges coupled to a time delay sequence. (Illustration 1) The material shot free of the hole was loaded on

a dump truck with a front end loader; the rock was then used as road riprap. Inspection of the area revealed that the heavy charges blew away much of the vegetative canopy and barked surrounding trees.

In order to retain a natural appearance, it is advisable to use lighter charges and excavate the materials from the hole with a back hoe or clam shovel. This procedure would entail diverting the water around the work site during excavation. Objectionable drilling silt would be

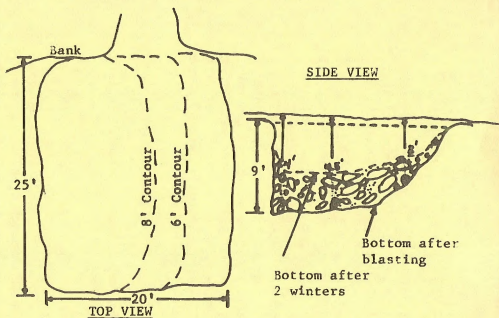
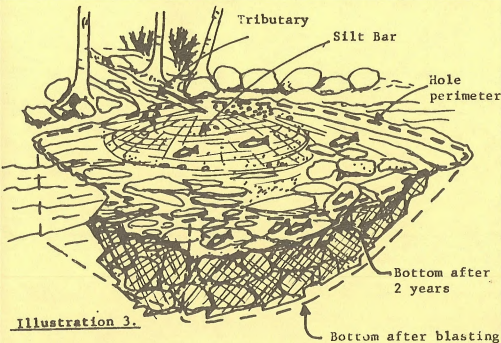
The pool was created at the mouth of a small tributary in order to take advantage of the cold water supplied in warm weather. During summer low flow, Vincent Creek was approximately 50 feet wide in this area and about 2 to 3 inches deep over a solid sheet of bedrock. (Illustration 5) The resulting pool was approximately 20 feet long and 25 feet wide. The upstream end was about 9 feet deep and downstream end 4 to 5 feet deep. (Illustration 2)

The test hole was blasted out of a flat sheet of bedrock which did not result in a high plunge at the head of the pool necessary for complete flushing. The gradient of the stream provided only a 3 to 6-inch plunge at the head of the pool. The test pool should have had at least a one-foot plunge to keep the pool flushed. Consequently, the pool has filled to a depth of 4.5 feet as shown in Illustration 2.

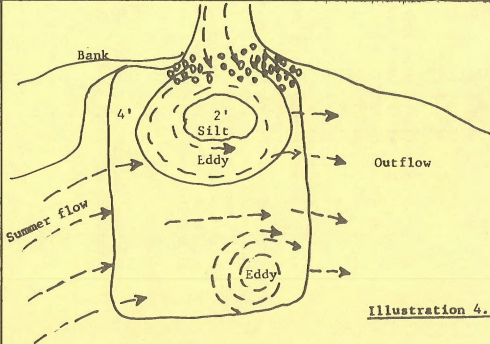
Illustration 4.

The pool has now been subjected to two winters of severe high water. A state of "natural repose" appears to have been reached at about 4.5 feet of depth. Some silted gravel is deposited around the less turbulent areas of the pool and these fluctuate 1-1½ feet annually depending upon severity of freshets. Illustration 4 shows the general flow patterns that have developed in the pool.

FLOW PATTERN

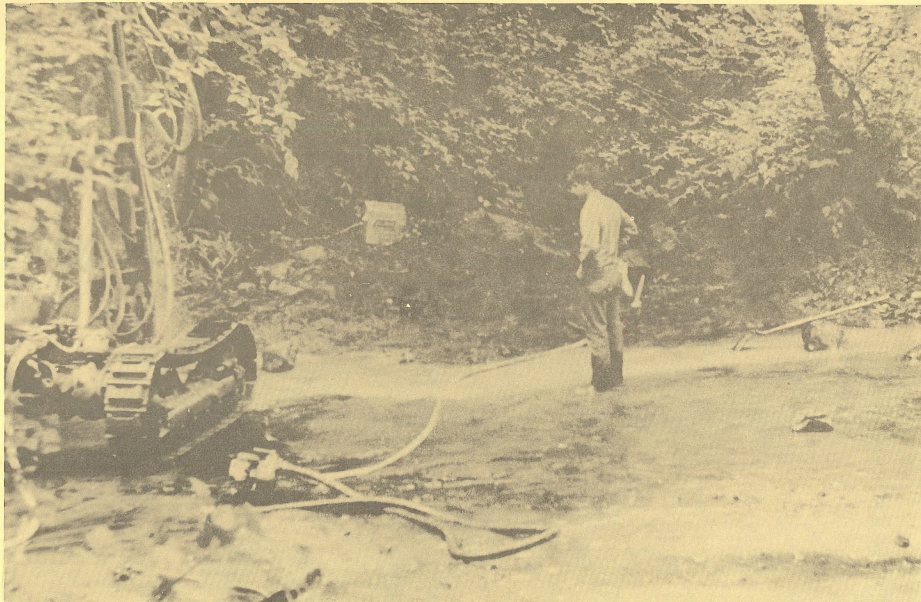
Illustration 5.

Track drill and operator working during late summer low flow. The Alder tree in the upper right corner of the photo can be used as a reference mark when viewing the pool after creation as seen in illustration 6.

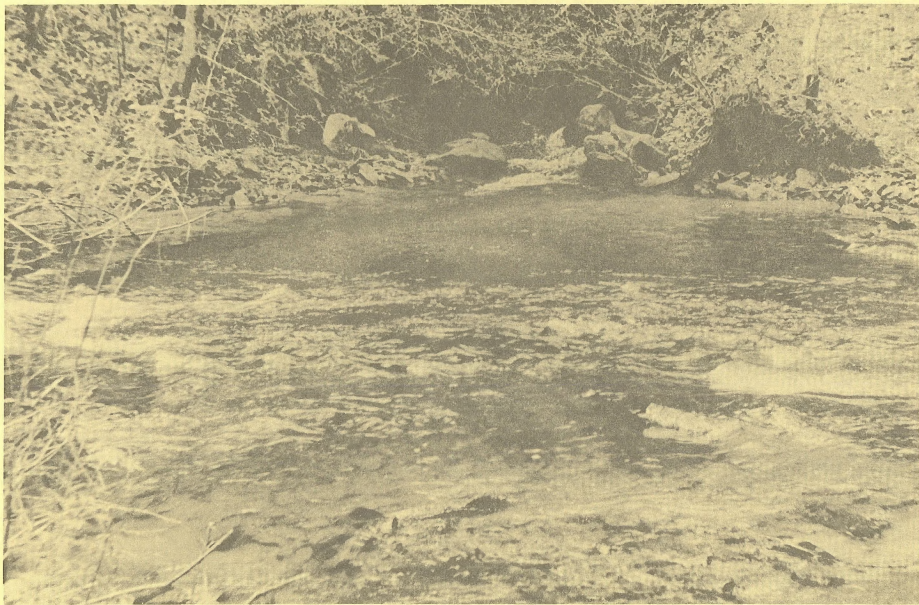
Illustration 6.

Photo of test pool taken after creation during a period of moderate winter flow. Note the slack water area on the far side of the pool where an eddy has formed at the mouth of the tributary.
